EXPERT'S REPORT

The present report was unanimously requested by the General Meeting of *Playa Flamenca X* in 2016. Our appointment was approved by the President and Committee of the Community and authorized by the President, whose full name is Antony Colin Mayes, with the counsel of the administrator Sonia Cirielos, in order to perform the Expert's Report, to rule on the pathology of the structure and finishings of the real estate properties that form the Urbanisation P Flamenca, located at CL 3 3 Rs Las Palmeras in Orihuela Costa, municipality of Orihuela – Alicante, according to the cadastral plot under number 9213811XH9091S. In order to issue the proper Expert's Report, on the 6th of March of 2017, we proceeded to the inspection visit of the place described before to practice the proper inspection prior to the requested study, and therefore, once in the abovementioned location and being assisted by the President, Antony Colin Mayes, as verbally appointed agent/legal representative of the said Community, the inspection began.

Description

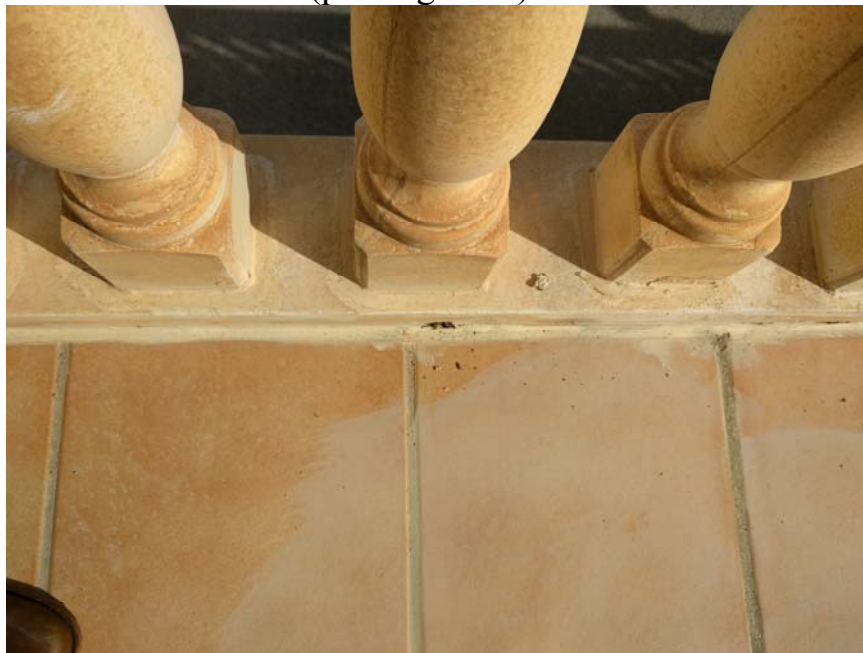
Corridors that give access to the dwellings have no general maintenance, which has led to the appearance of cracking in the joints of their flooring (mainly ceramic), and in the proper joints with the protection and separation balustrades that are, in our opinion, the reason for the leakages on the inferior floor (parking units).

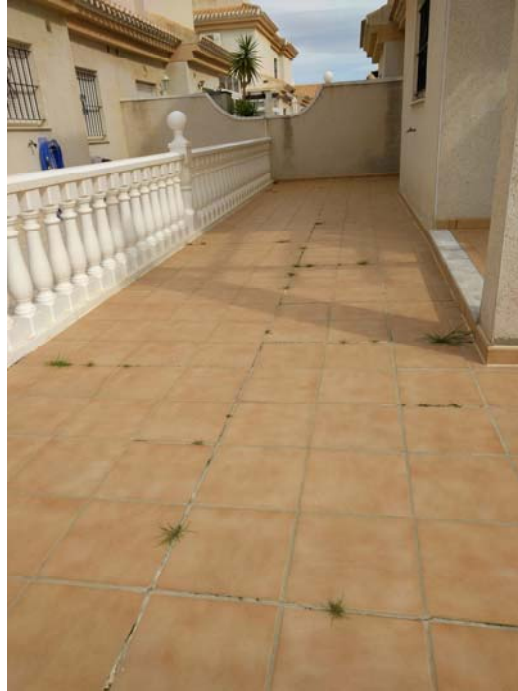
We have also observed that in different lateral courtyards of certain dwellings no maintenance has been performed, and therefore, at first sight, there is a lack of joint treatment between the different pieces, which also contributes to the different leakages detailed in the photographic documents attached herein.

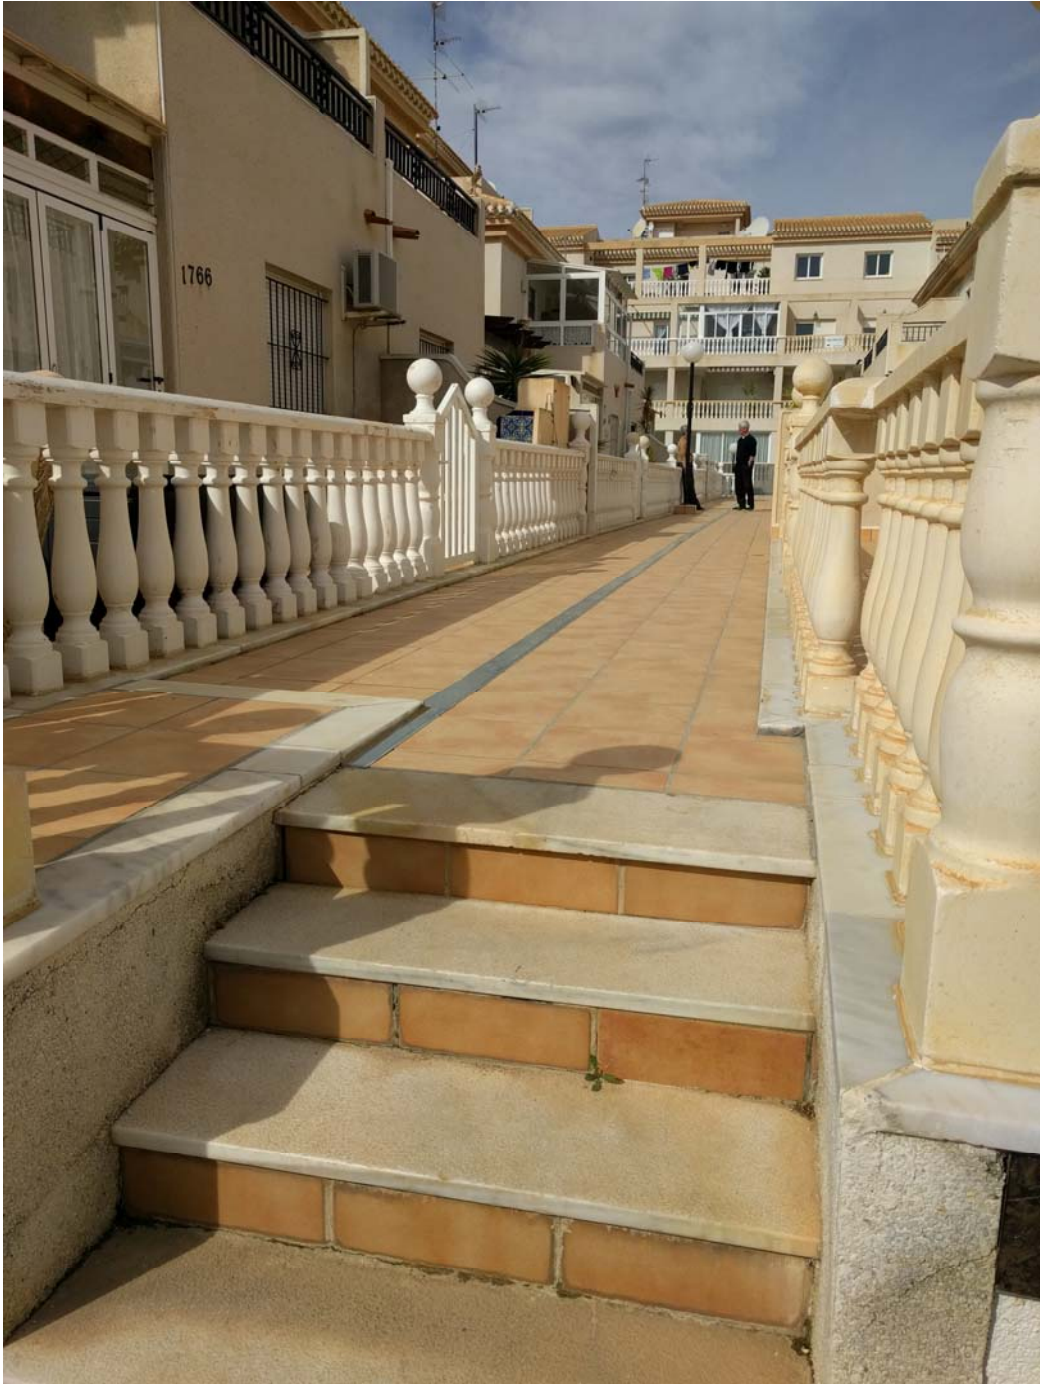
During the inspection performed, while observing the new construction/refurbishment of one of the access stairs to the community corridors, we saw that there was not any kind of anti-leakage asphalt roofing felt, which undoubtedly causes dampness by leakage on the inferior floor.

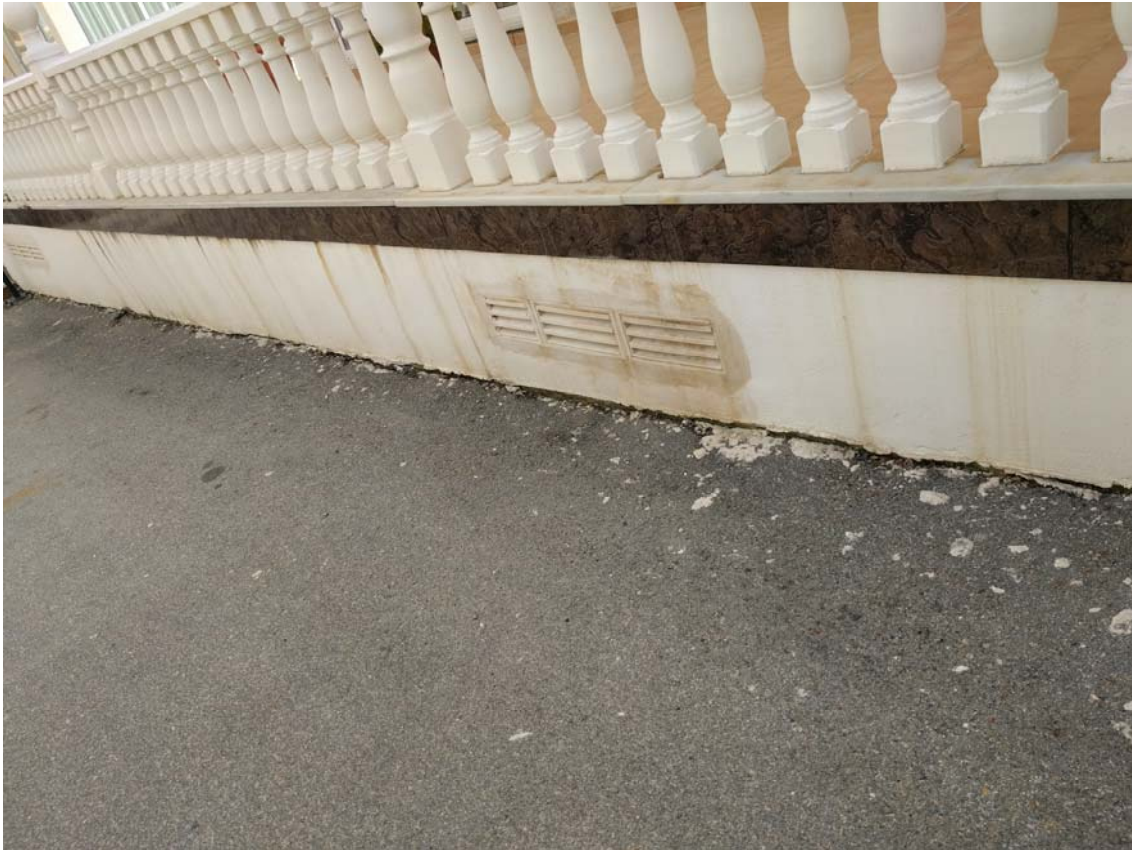
Access to parking units.- Access is through the exterior ramp of bituminous asphalt, whereas on the day of the inspection we observed bad condition both in its execution and in the finishings and joints with exterior vertical parameters.

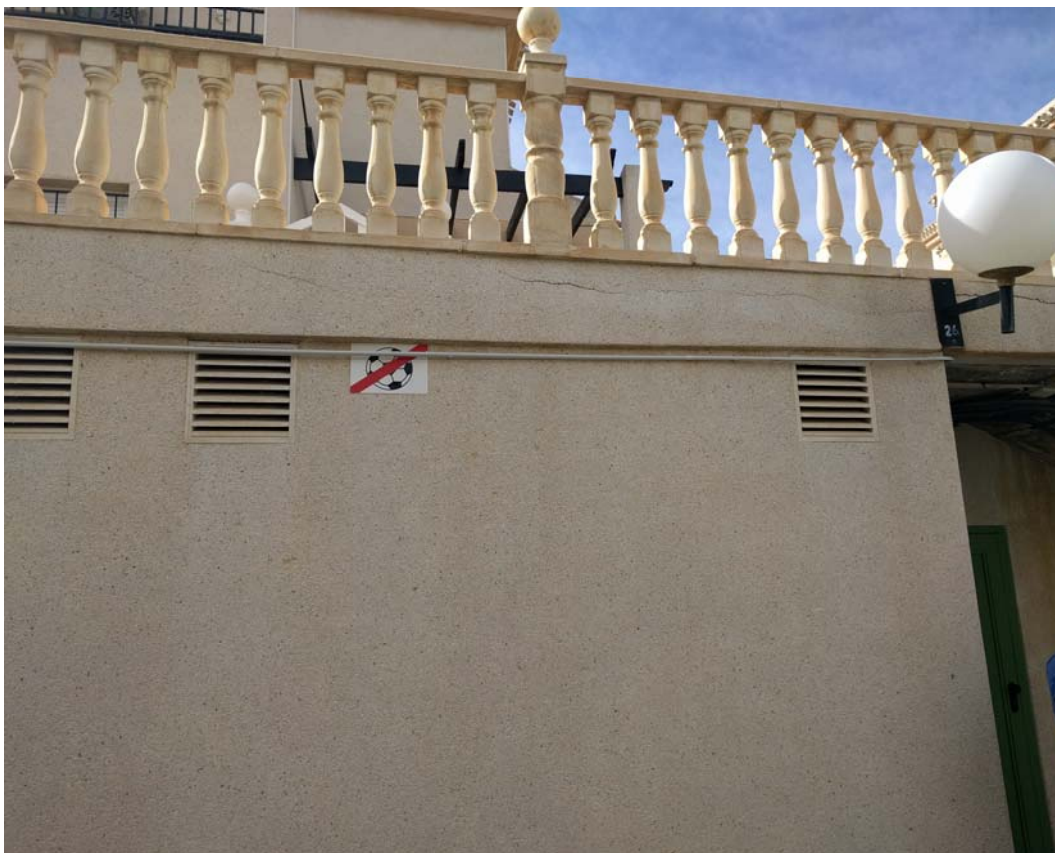
Exterior vertical faces.- The exterior vertical faces made as walled enclosures for the parking units have been made with 20x20x40 concrete blocks finished with *cotegran*, but nowadays they are all in poor condition due to the lack of maintenance which, in our opinion, has been non-existent from the date of termination of the works to present day. This has produced cracking, which has also led to water leakages and several dampness.

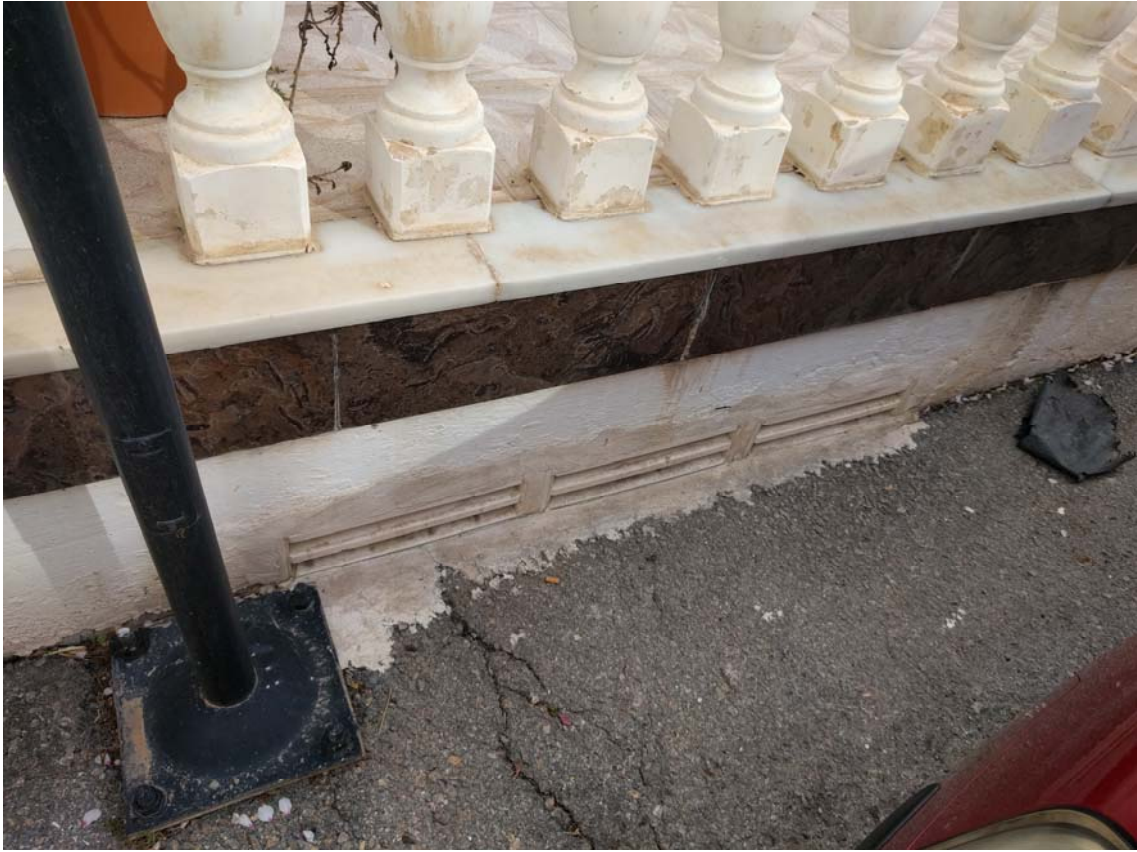
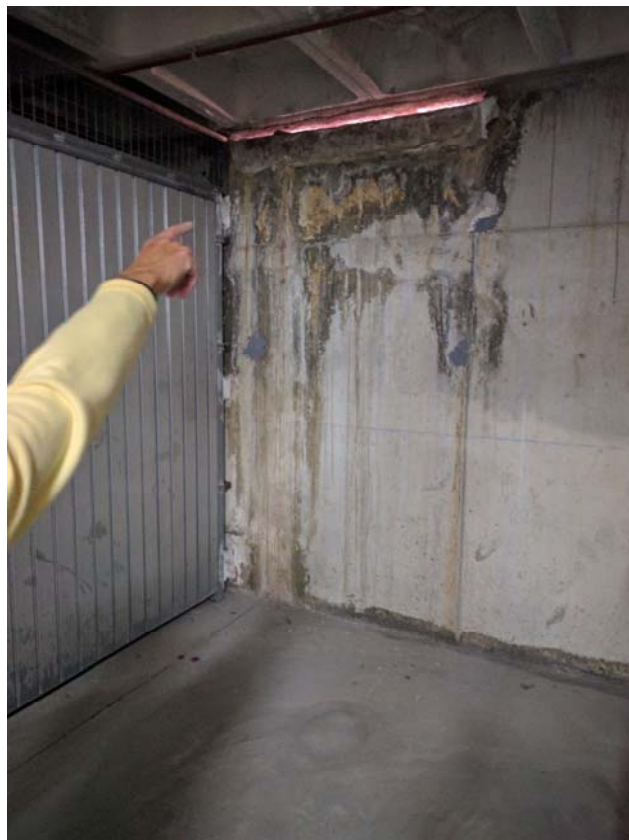
We have observed that the exterior air intakes are at the same height as that of the asphalt irrigation, which causes the entry of water directly, leading to the existing dampness.

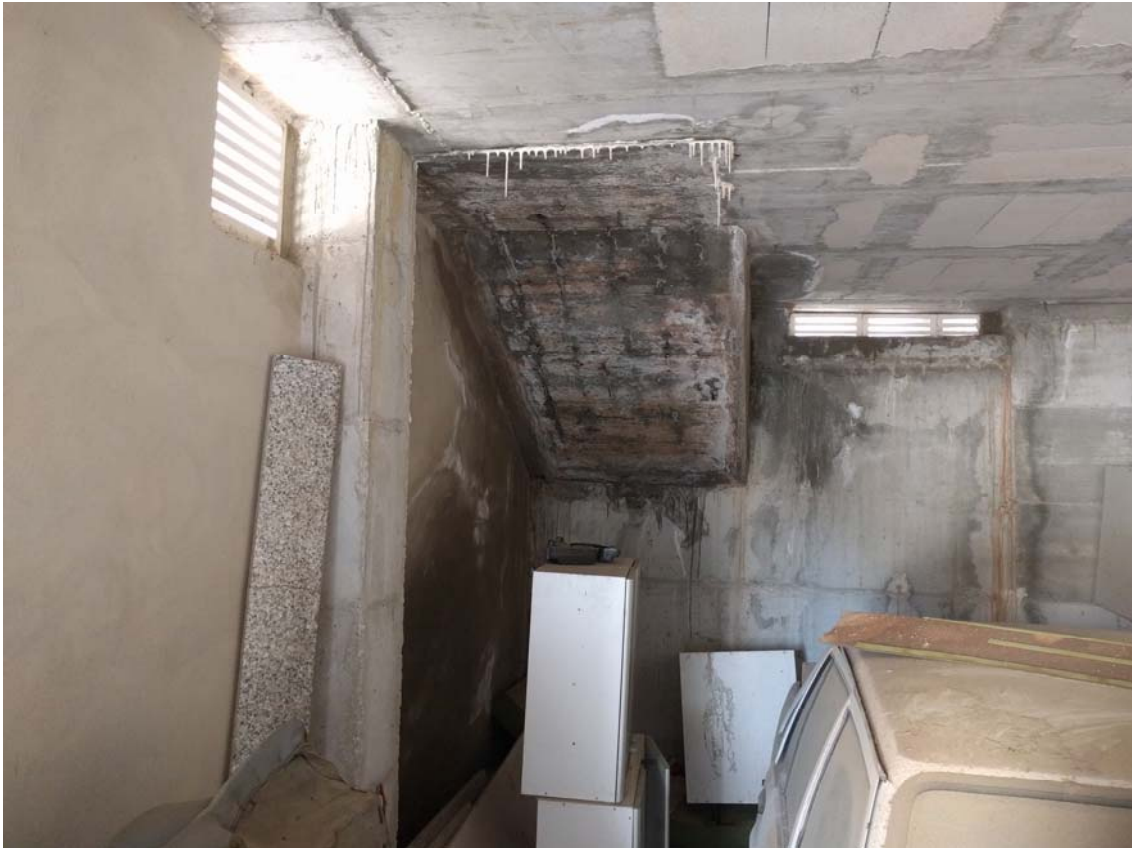
Interior vertical faces.- They have not got any kind of finishing, as they are in their primary state, being affected by the dampness from outside, especially in the stairs located on the left said of the parking area by its main entrance, and therefore, it is convenient to repair the damages observed both outside and inside.

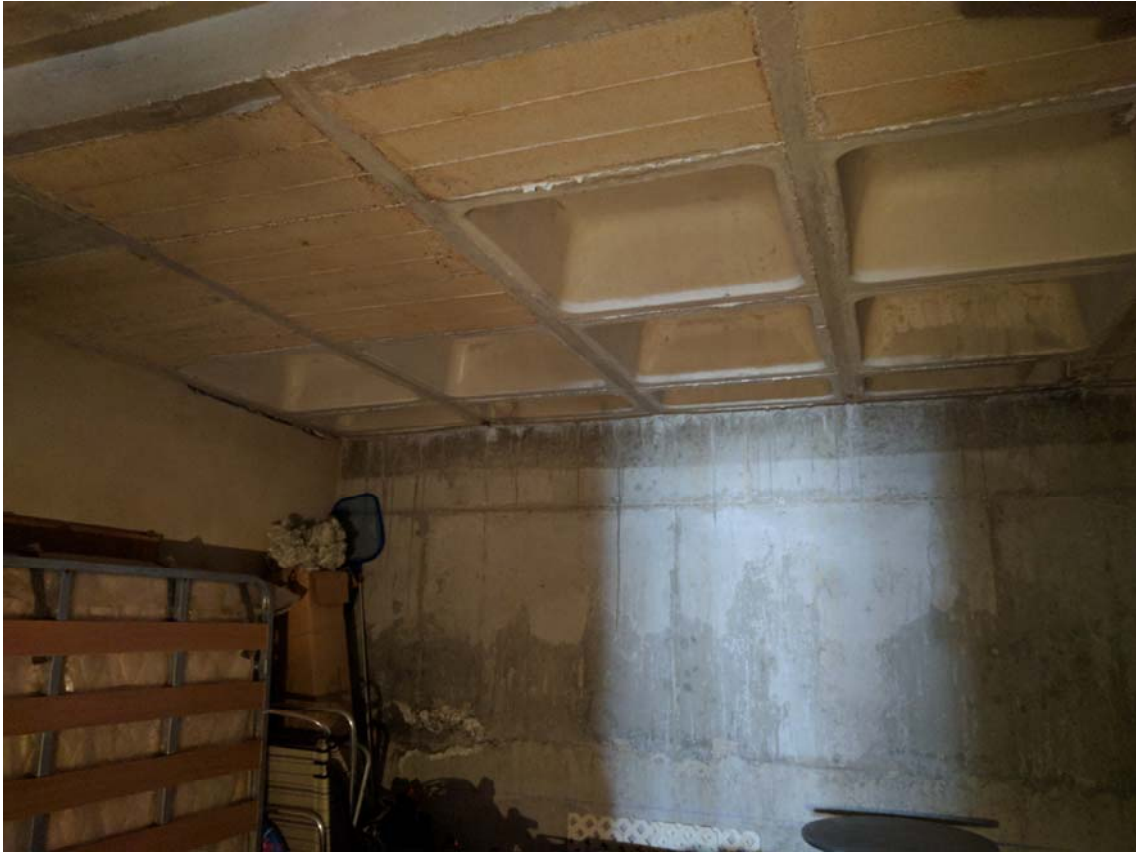
Upper horizontal face (ceiling).- It is made with pre-stressed concrete beams forming 20x40x80 river block floor units, in which we have seen in other parts other ones of 80x80 interspersed, without an apparent previous explanation for their use, as they are in good condition except for five of them that show a light cracking from where small leakages take place, whereas this is a susceptible cause for repair without great economic costs.

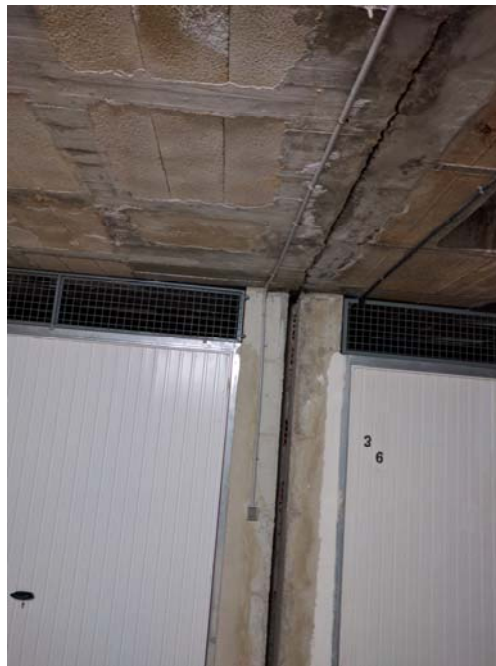
In the inspection performed, we have been able to check the poor state of the expansion joint that, although it was once repaired and masked with a metal “crackfiller”, a new adaptation should be considered, due to its bad execution.

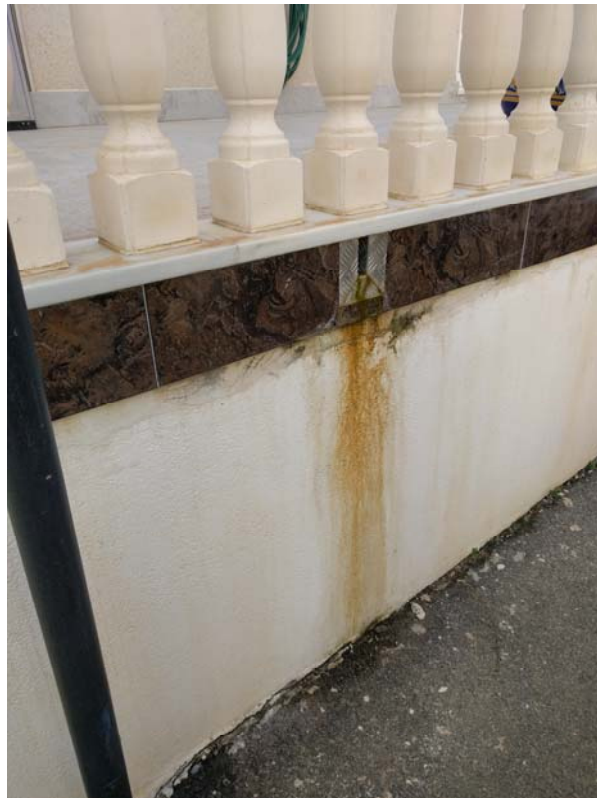
Photograph no. 1

We may observe on its side, both in its central part and near the joint sealer, the existing scaling with a loss of plaster and a gap between the joints of the central joining piece.

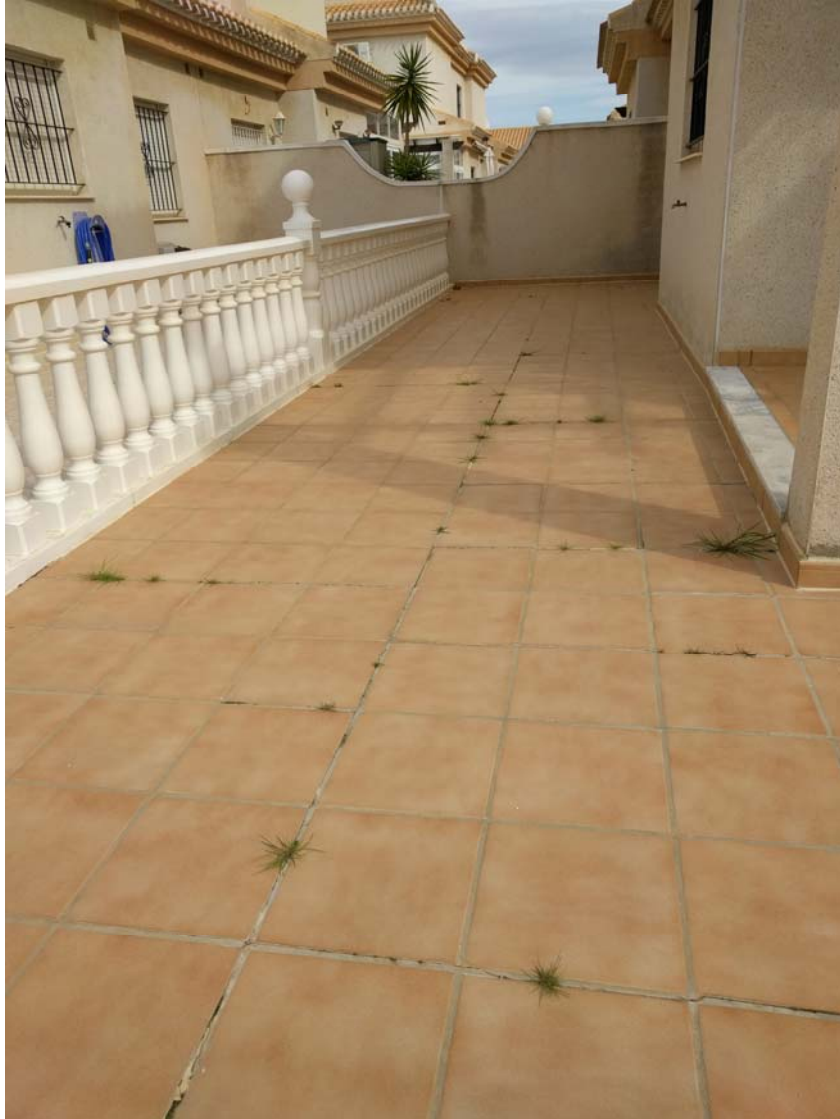
Photograph no. 2

We may observe quite clearly the cracking of the joint seals and therefore water leakage through them, due to the absence of a waterproof membrane that must be vertically extended in the joint of the façade of the dwelling and the exterior paving.

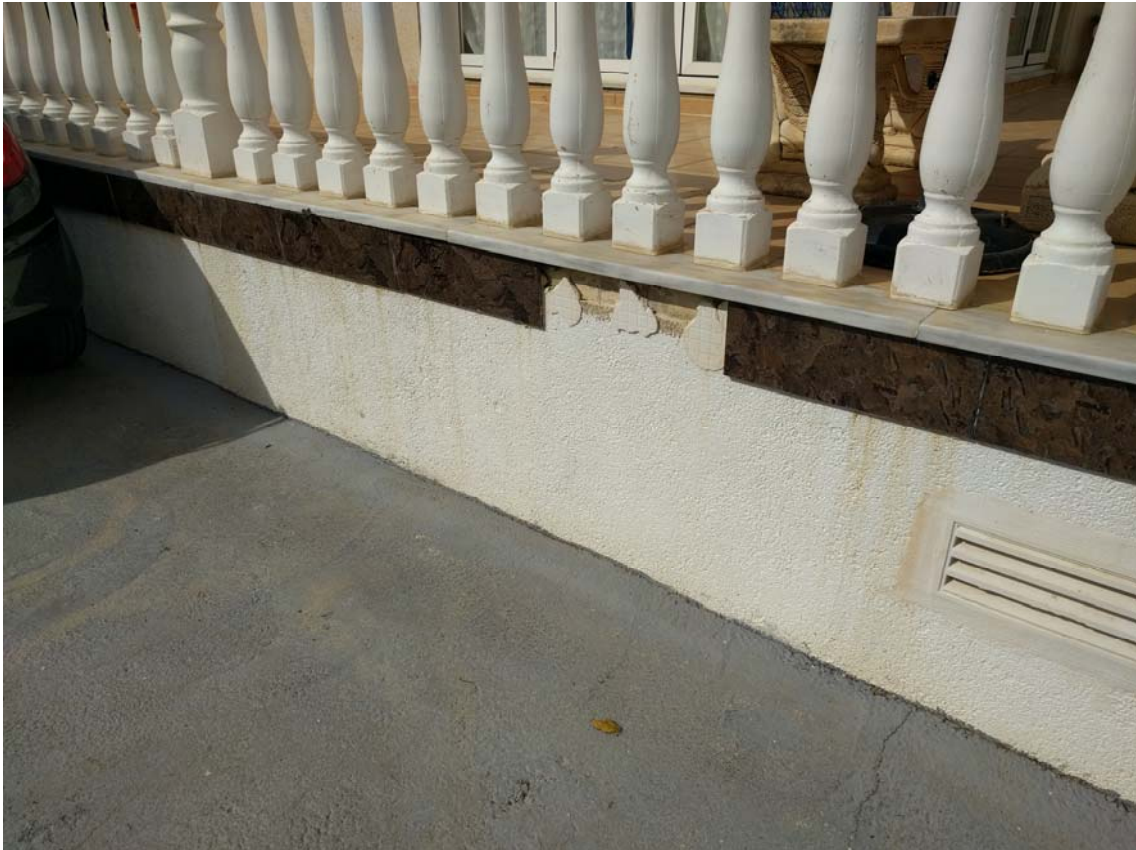
Photograph no. 3

Loosening of a ceramic piece from the exterior lateral wall of the parking units.

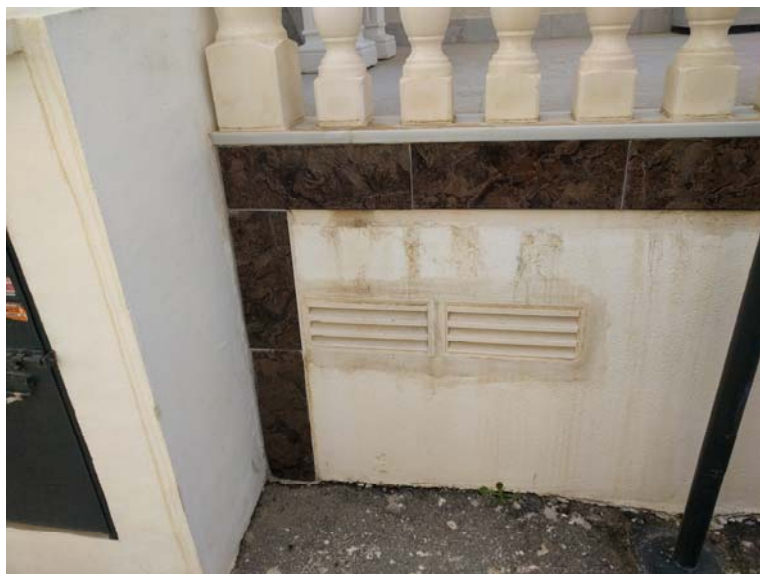
Photograph no. 4

As in photograph number 2, we also see the cracking in one of the joint seals and the loss of finishing plaster in the area.

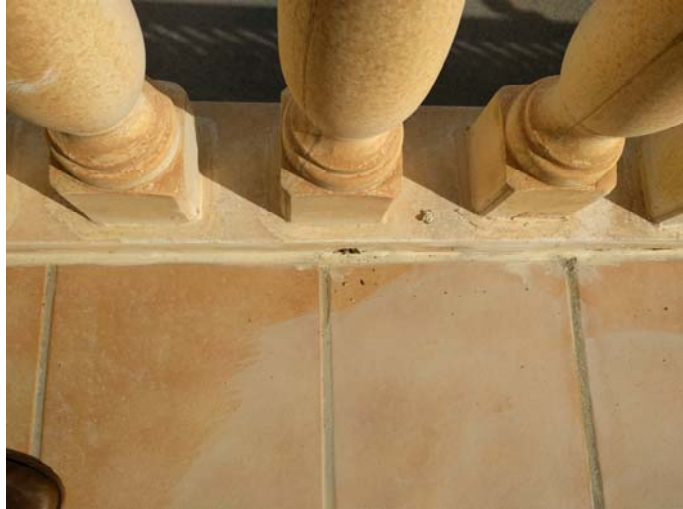
Photograph no. 5

On the superior left angle we may see the poor finishing of the joints of the faces as well as the loosening to which we referred to as in the previous photographs.

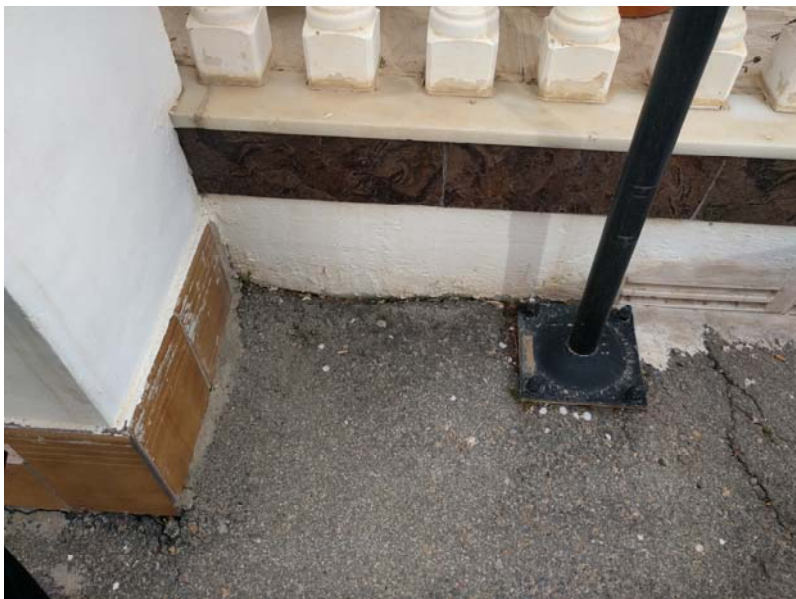
Photograph no. 6

As usual with the exterior face around the parking unit, again we see finishing crumbly on the lower part of the same and its joint with the asphalt which gives access to the entry to the parking unit.

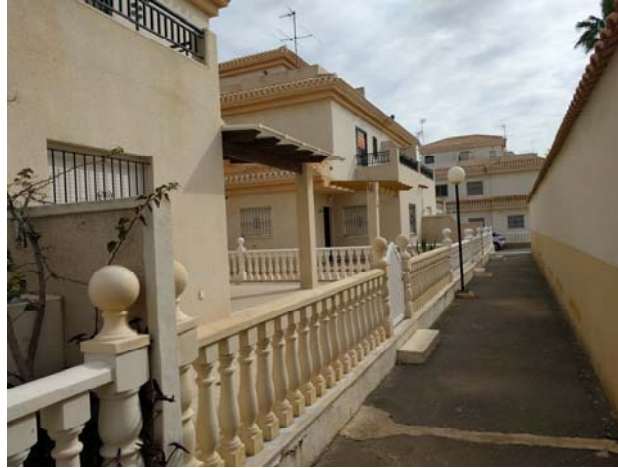
Photograph no. 7

Following with the usual keynote within the joint seals of the façades of the dwellings, we see the loosening of the finishing mortar near the area where the parking area has been built.

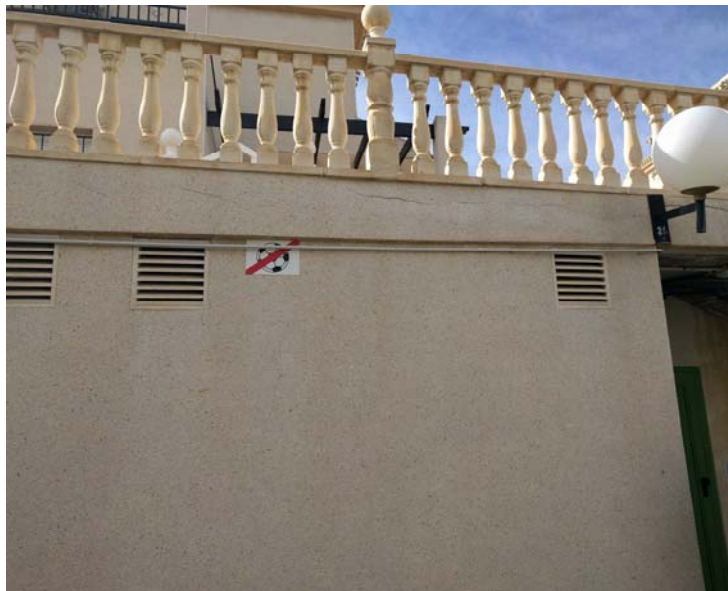
Photograph no. 8

Maybe on this side you may observe clearly the bad finishing and maintenance of the *cotegran*, as there are evident crackings on it, which causes the abovementioned leakages.

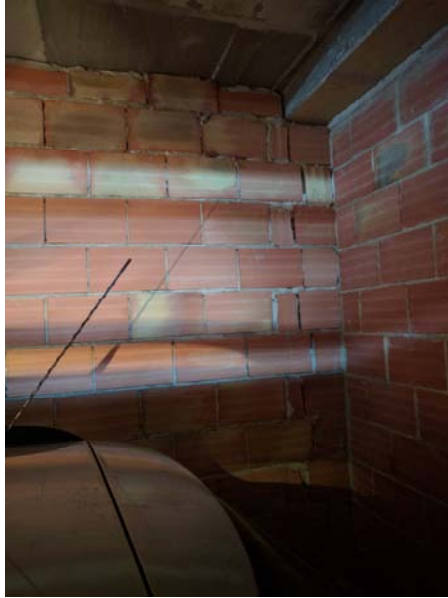
Photograph no. 9

In these photographs you may easily see that the inner partition walls have been marked in different parking areas, maybe due to the slump of the different faces.

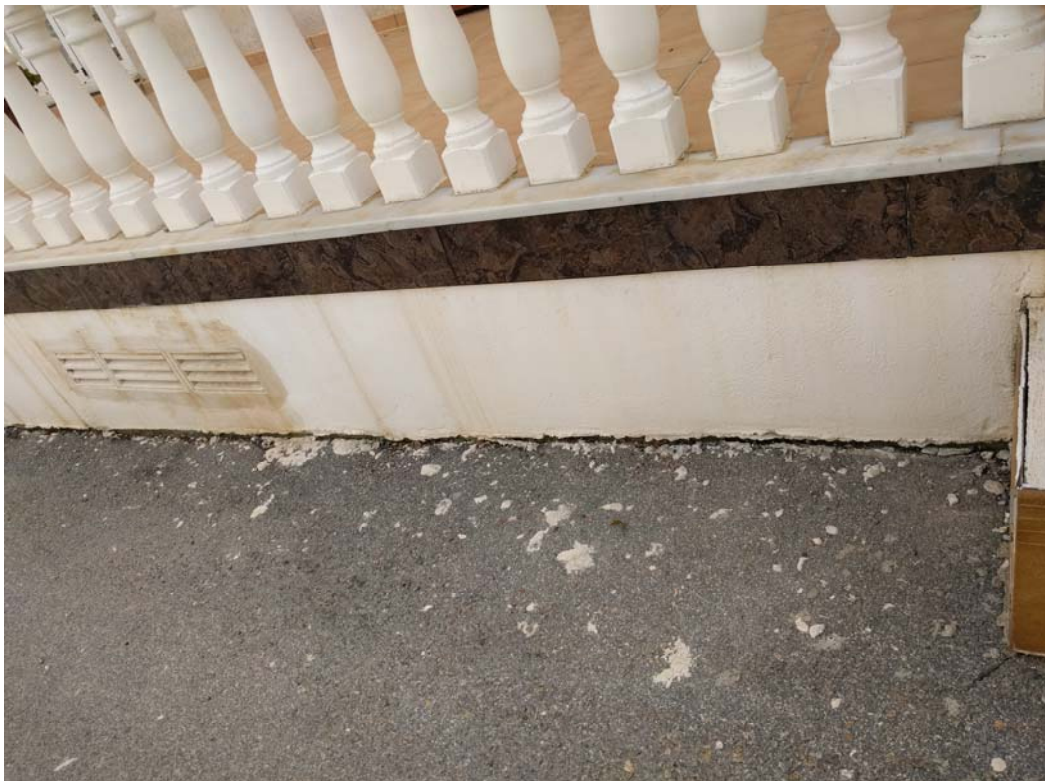
Photograph no. 10

As we may see clearly, there is a bad finishing and joint treatment between the closing wall and the perimeter façade of the urbanisation.

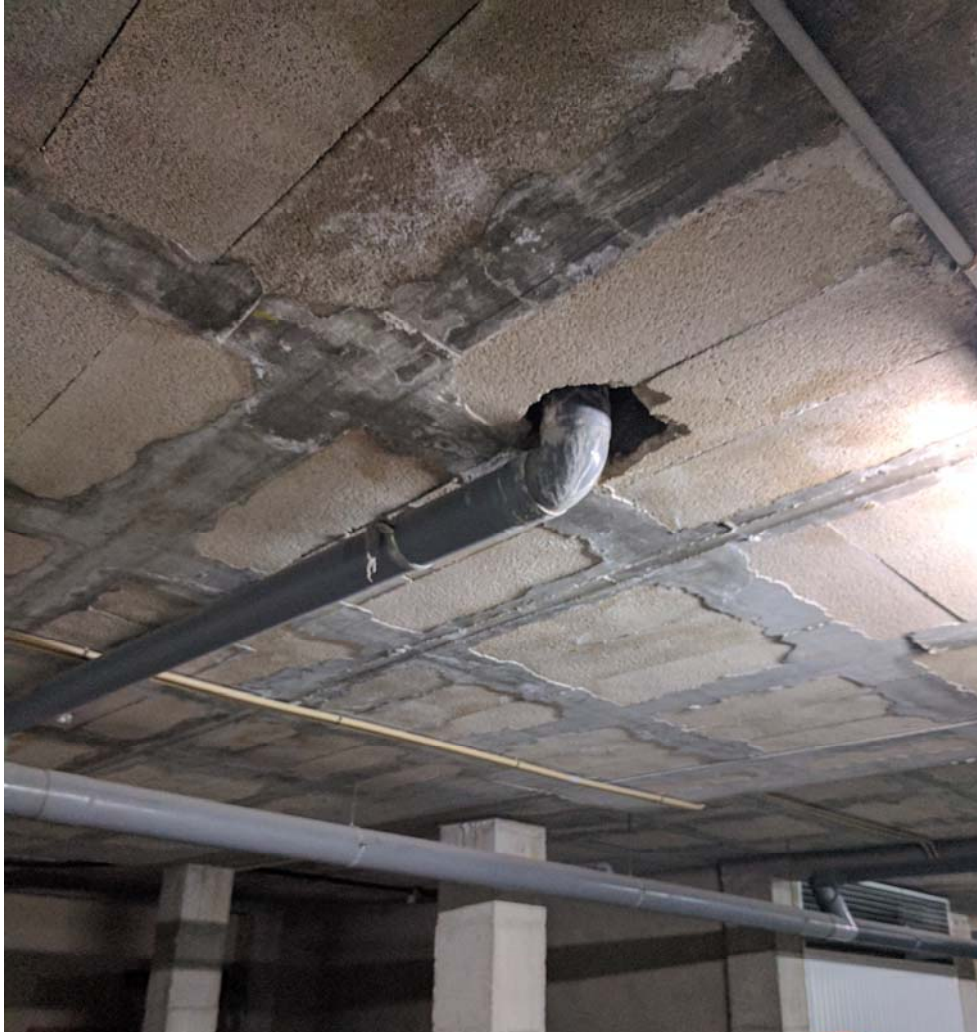
Photograph no. 11

We may also see that the supplies for sanitary facilities and water service for domestic use have not been made in accordance with the current regulations in force, as the downpipes occupy common spaces within the different parking units enabled.
